Property Inspection **REPORT**

██████████, Temple, 76502

DATE OF INSPECTION: 3/19/2026

PROPERTY INSPECTION REPORT FORM

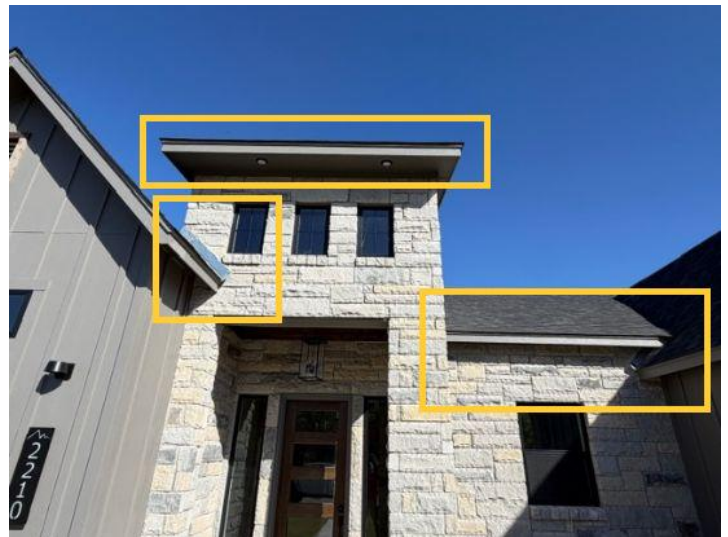
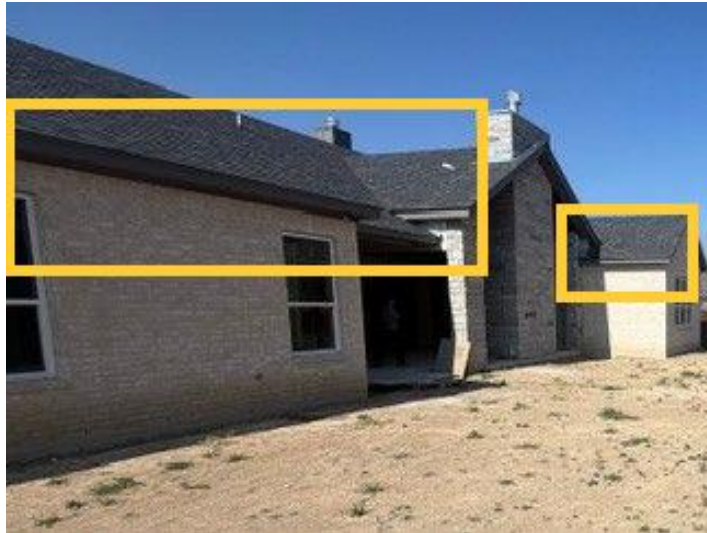
• Observation: A gutter system is not installed in certain areas of the home where roof runoff may discharge directly adjacent to the foundation and near entry points.

Implication: The absence of gutters in these areas may allow water to accumulate near the foundation and entry points, potentially contributing to soil movement, moisture intrusion, or premature deterioration over time.

Gutter System Recommended

Recommendation: Recommend budgeting for the installation of a gutter system in the affected areas to help direct water away from the foundation and improve drainage control.

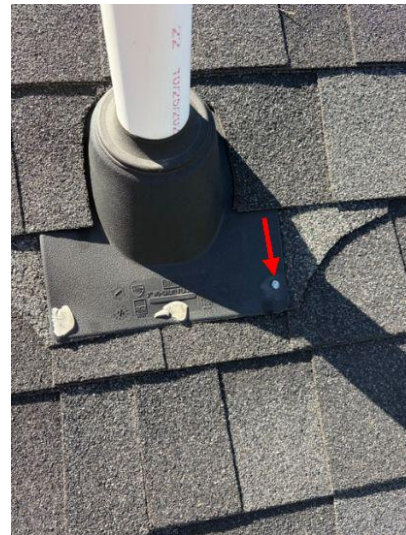
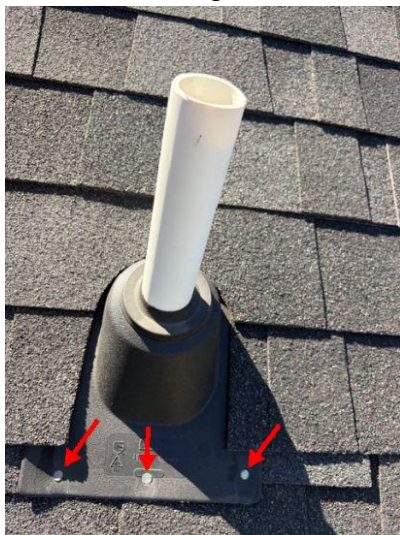
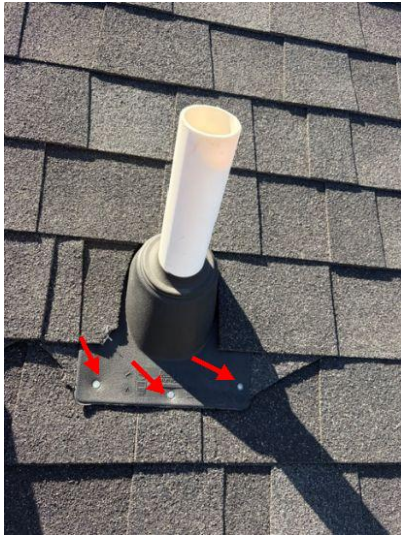
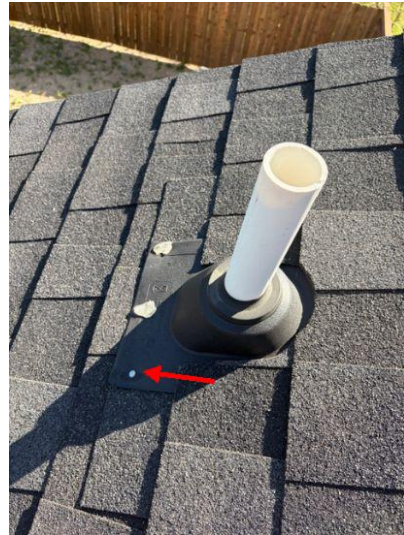
- Observation: Exposed nails were observed at some of the plumbing vent flashing locations.

Implication: Exposed fasteners are susceptible to moisture intrusion over time, which can lead to leaks and potential damage to underlying materials.

Exposed Roofing Nail

Recommendation: Recommend the builder seal all exposed nails and verify that all roof penetrations are properly sealed to prevent water intrusion.

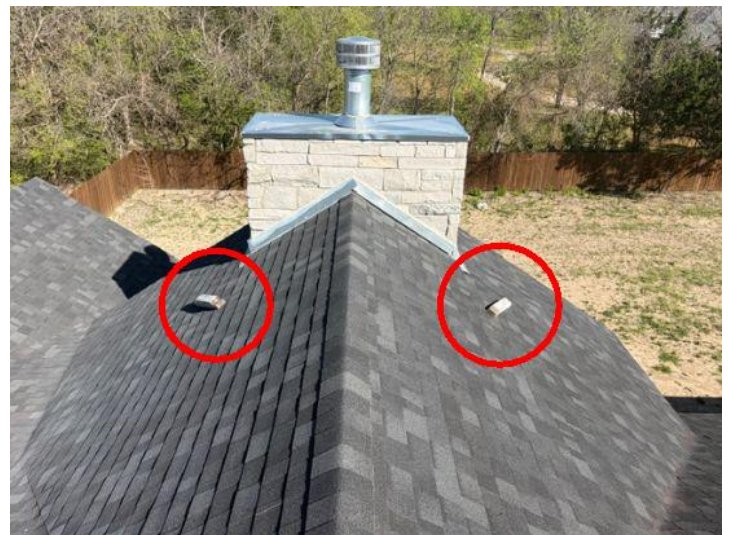
- Observation: Two pieces of 2x4 lumber were observed nailed to the roof surface near the patio chimney.

Implication: Penetrations through the roofing material without proper sealing can allow water intrusion, potentially leading to deterioration of roofing components and underlying structures.

2x4s Nailed to the Roof

Recommendation: Recommend removal of the 2x4s and proper sealing of all penetrations at those locations by the builder to prevent future water intrusion.

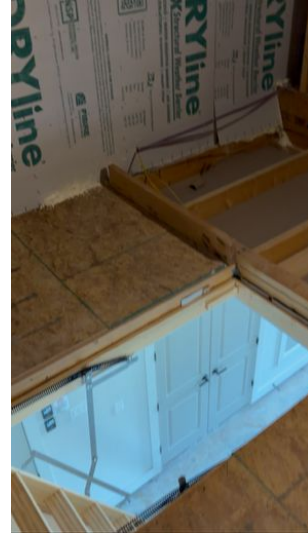
Attic Access

Implication: Difficulty operating the attic access may indicate improper installation or alignment, which can lead to usability issues and potential damage to the unit over time.

Recommendation: Recommend the builder make necessary adjustments to ensure proper operation of the attic access ladder.

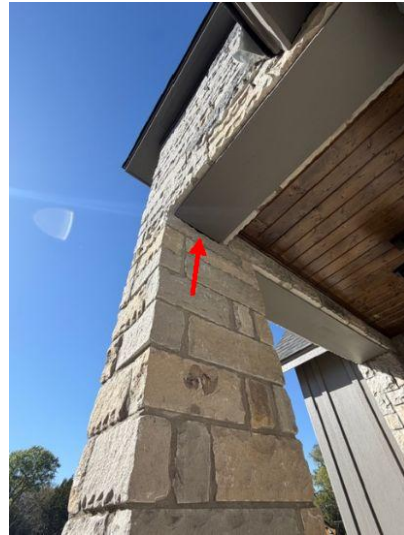
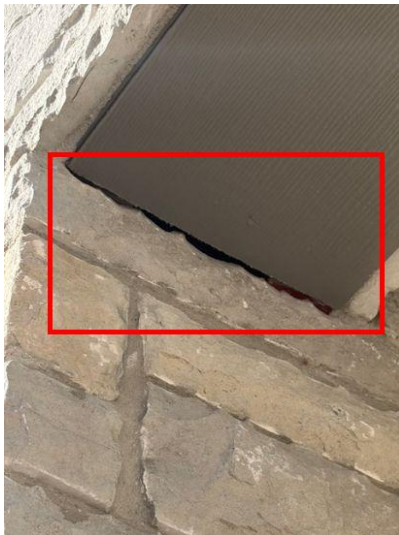
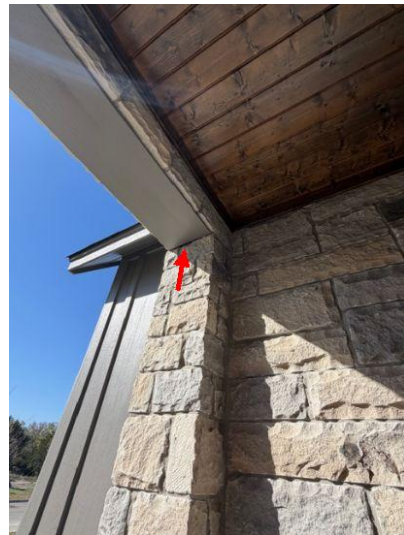
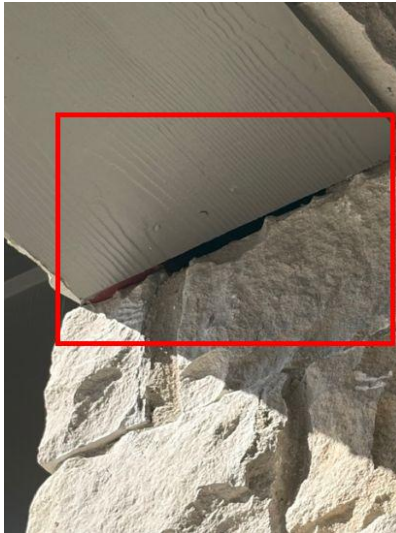
- Observation: Gaps were observed at select areas of the exterior walls, including above the columns near the front entrance and between the frieze board and wall surfaces, where sealing was incomplete or missing.

Implication: Unsealed gaps may allow moisture intrusion and pest entry, which can lead to deterioration of materials and potential interior damage over time.

Gap between stone veneer cladding and soffit

Recommendation: Recommend the builder perform a walkthrough and properly seal all identified gaps and similar areas to help prevent moisture and pest intrusion.

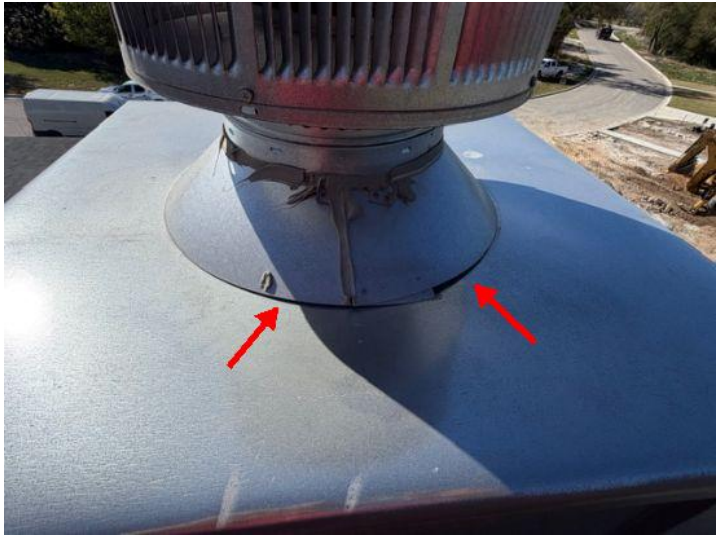
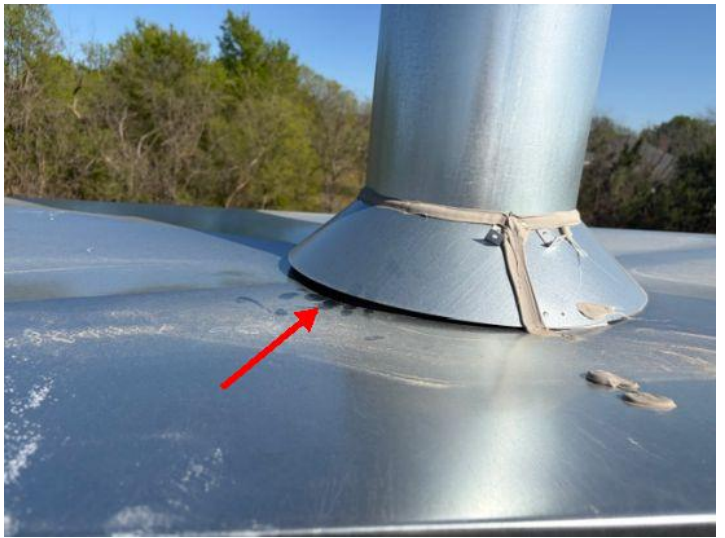
- Observation: Gaps were observed between the storm collars and the chase covers at both chimneys. Sealant was either missing or inadequately applied at these locations.

Implication: Gaps at the storm collar can allow water intrusion into the chimney chase, which may lead to moisture damage, deterioration of components, and potential leaks over time.

Gap between Storm Collar and Chase Cover

Recommendation: Recommend the builder properly seal the gaps between the storm collars and chase covers to prevent water intrusion.

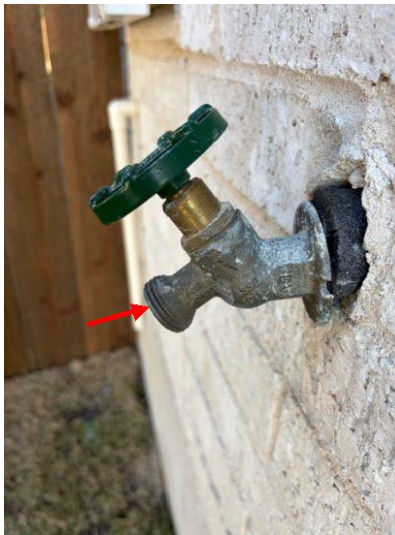
Missing Anti-siphon Device

Recommendation: Recommend installation of anti-siphon devices at all exterior hose bibs to help prevent backflow contamination. These inexpensive devices can be obtain at any local hardware store.

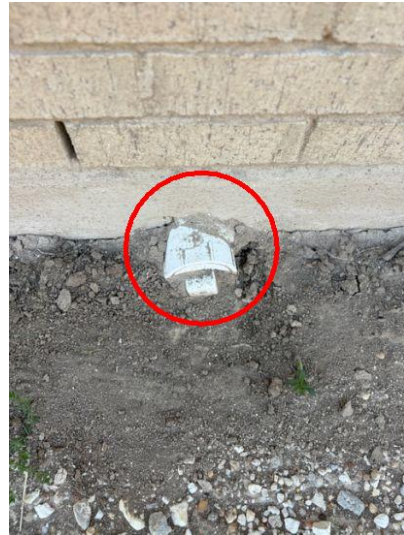
Obstructed Clean-Out

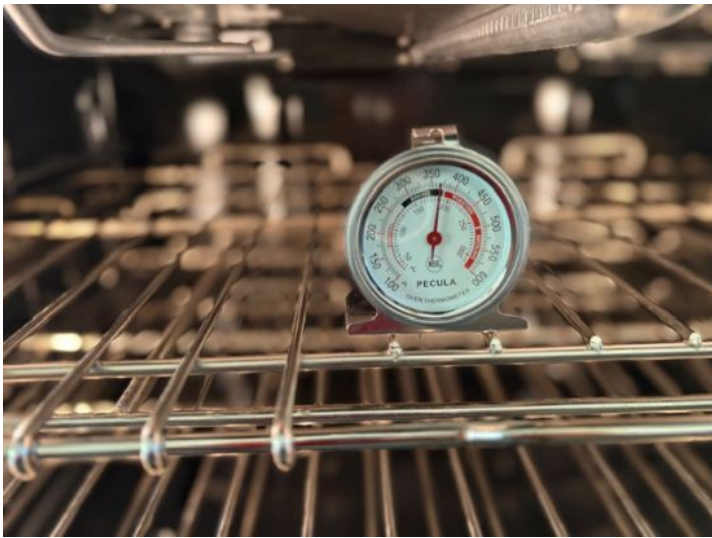
Gas Stove Oven Temperature Test at 350°F -
Reading at 365°F

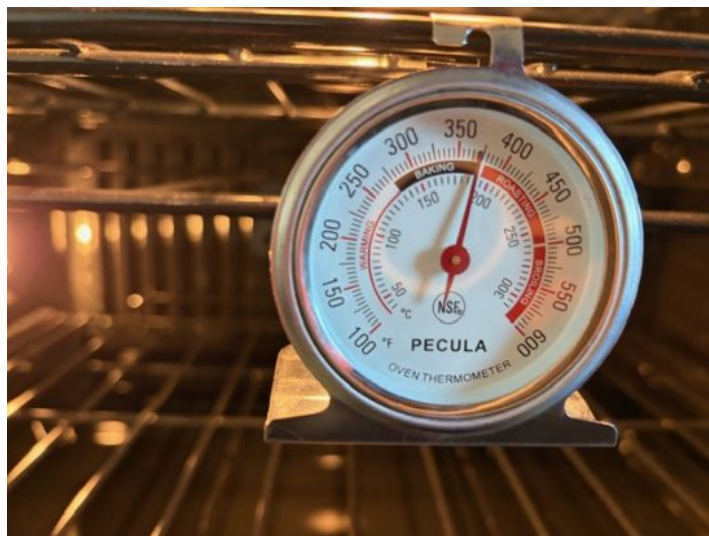
Stand-Alone Oven Temperature Test at 350°F - Reading 370°F

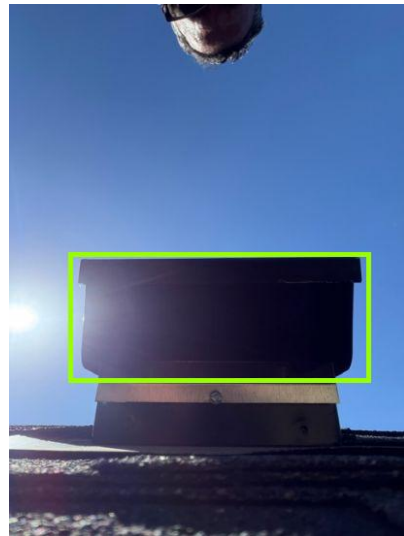
Roof Penetration Dryer Vent - No Grill
