Property Inspection **REPORT**

██████████, Temple, 76502

DATE OF INSPECTION: 3/19/2026

PROPERTY INSPECTION REPORT FORM

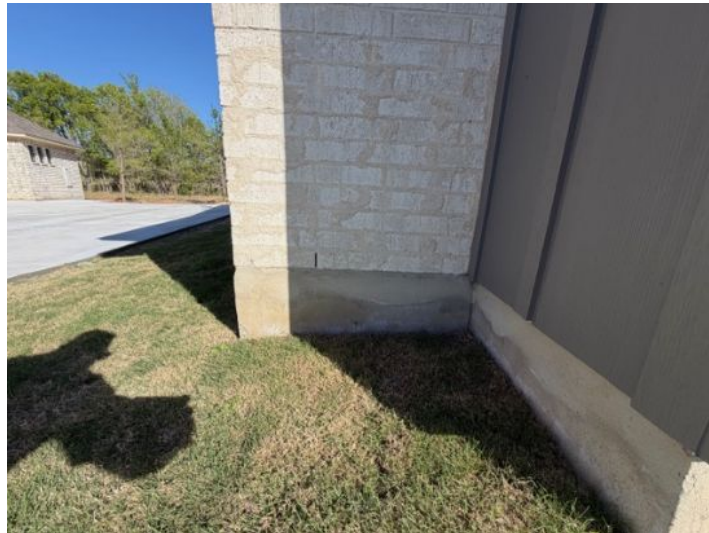
Foundation Wall

- Observation: The home is constructed on a slab-on-grade foundation. No visible deficiencies were observed at the time of the inspection.

Recommendation: No action required at this time.

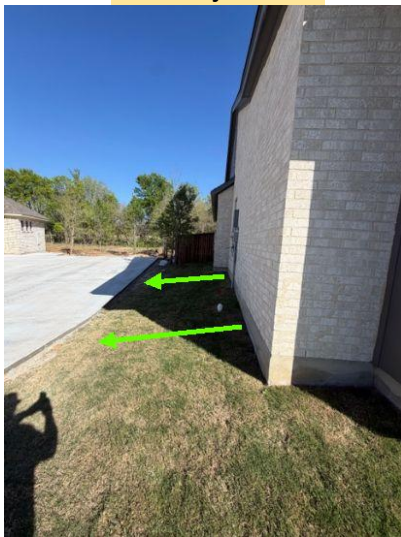
Positive Grade

• Observation: Positive grading was observed around the home perimeter, promoting drainage away from the foundation.

Recommendation: No action required at this time.

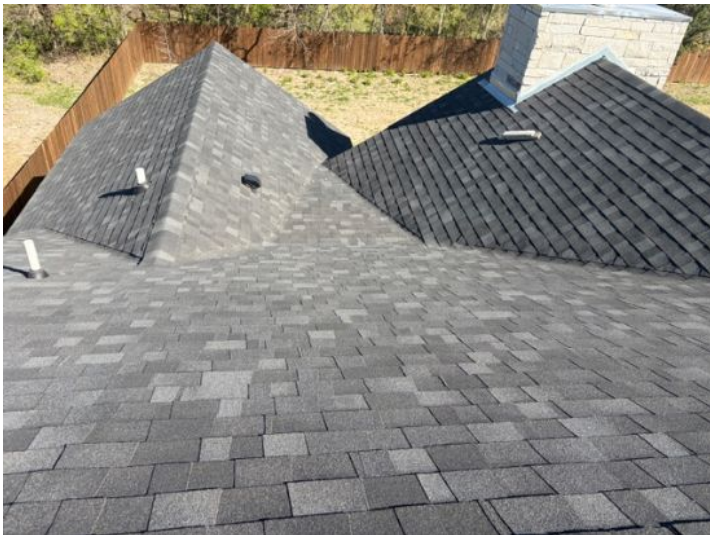
Roof Covering Material - Architectural Asphalt Shingles

- Observation: Exposed nails were observed at some of the plumbing vent flashing locations.

Implication: Exposed fasteners are susceptible to moisture intrusion over time, which can lead to leaks and potential damage to underlying materials.

Recommendation: Recommend the builder seal all exposed nails and verify that all roof penetrations are properly sealed to prevent water intrusion.

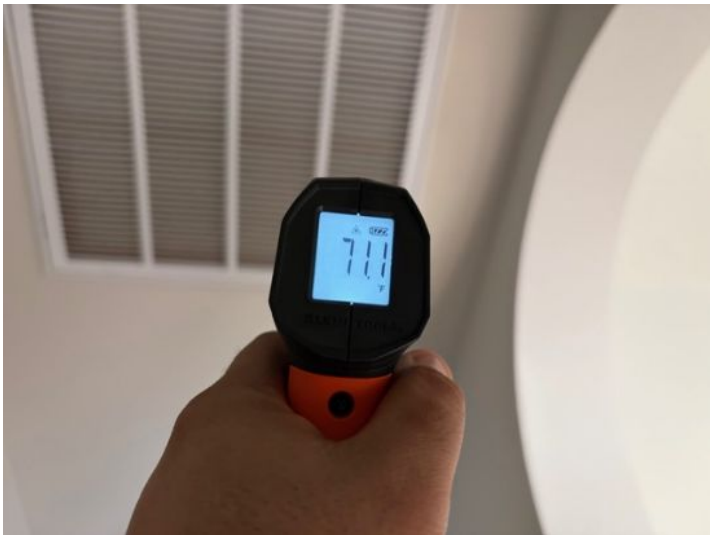
Cooling System Temperature Differential - 71.1°F at Return Register

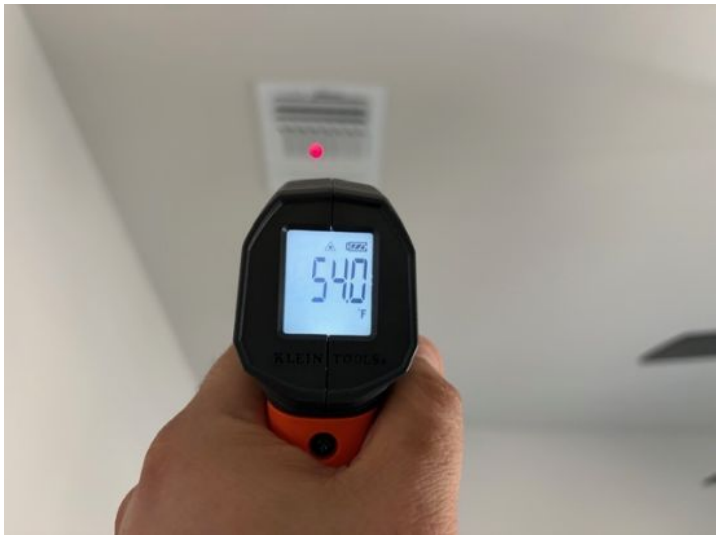
Cooling System Temperature Differential - 54.0°F at Supply Register

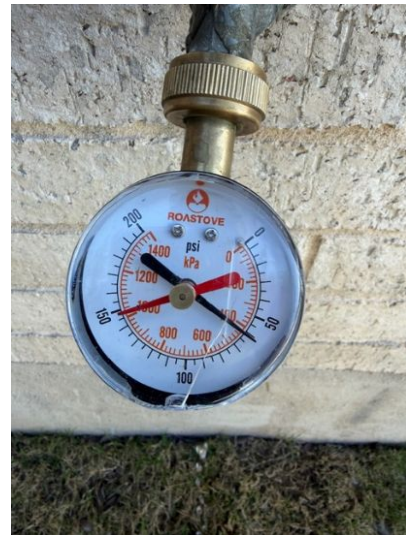
Static Water Pressure: 60 PSI

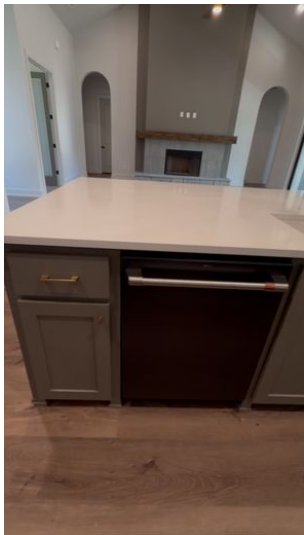
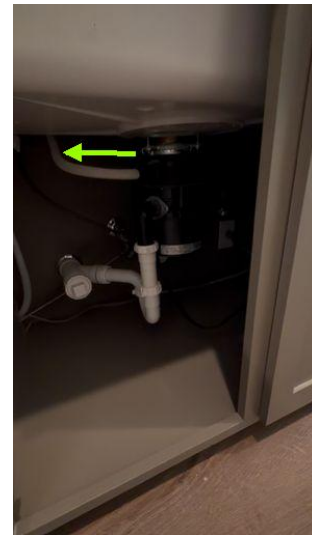
DW Drain Line High Loop

• Observation: The dishwasher was operated on a normal cycle and was found to be functional at the time of the inspection. Anti-tip devices were observed, and a high loop was present at the drain line. No visible deficiencies were noted.

Recommendation: No action required at this time.

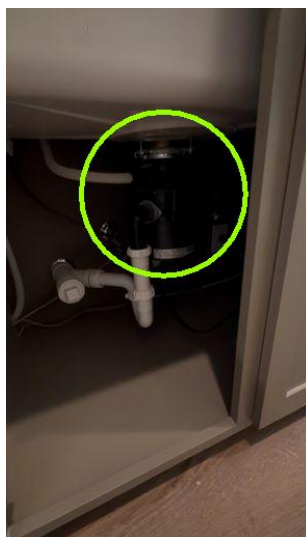
- Observation: The garbage disposer was operated and found to be functional at the time of the inspection. No visible deficiencies were observed.

Implication: Proper operation of the disposer supports normal kitchen functionality.

Recommendation: No action required at this time.

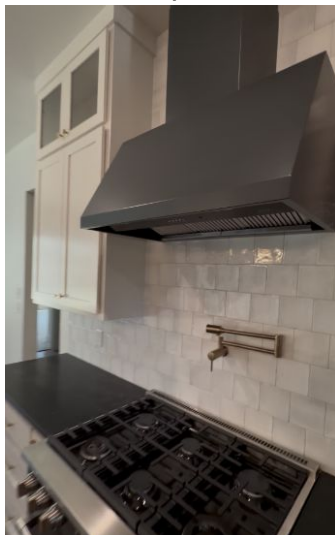
- Observation: The range hood was operated, including the fan and light functions, and was found to be fully functional at the time of the inspection.

Implication: Proper operation of the range hood supports ventilation and removal of cooking byproducts.

Recommendation: No action required at this time.

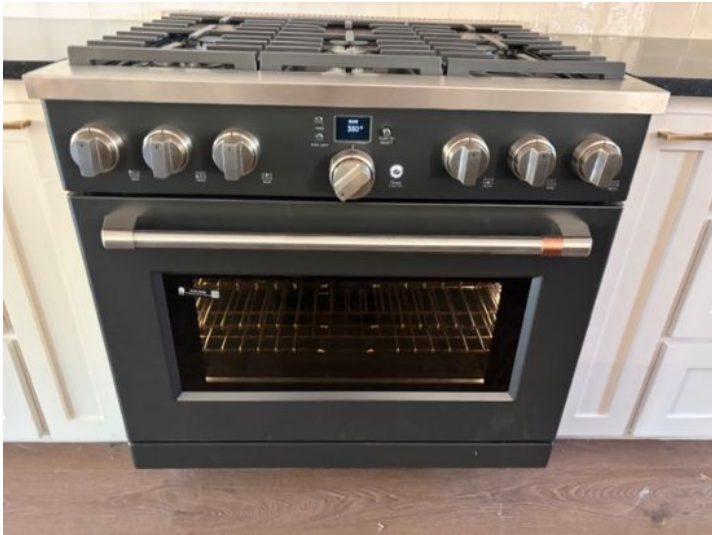
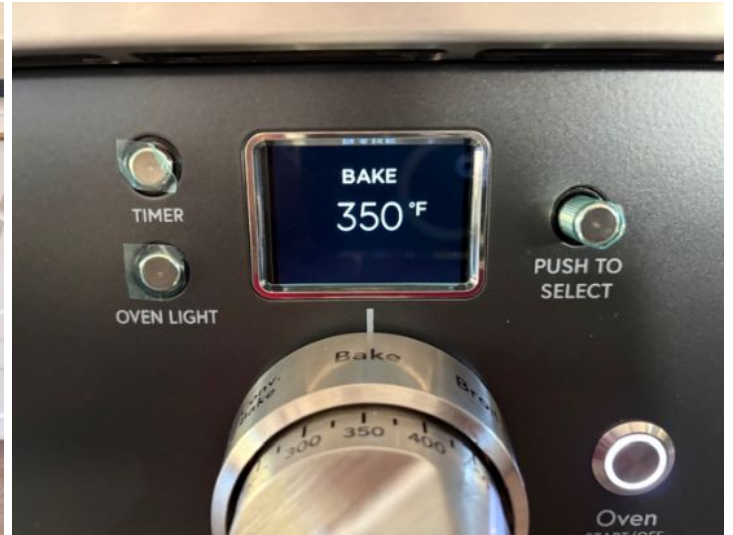
Gas Stove Oven Temperature Test at 350°F

- Observation: The gas range and oven were operated at the time of the inspection. All burners operated normally. The oven temperature was tested at 350°F and was found to be within an acceptable range ($\pm 25^\circ\text{F}$). No visible deficiencies were observed.

Recommendation: No action required at this time.

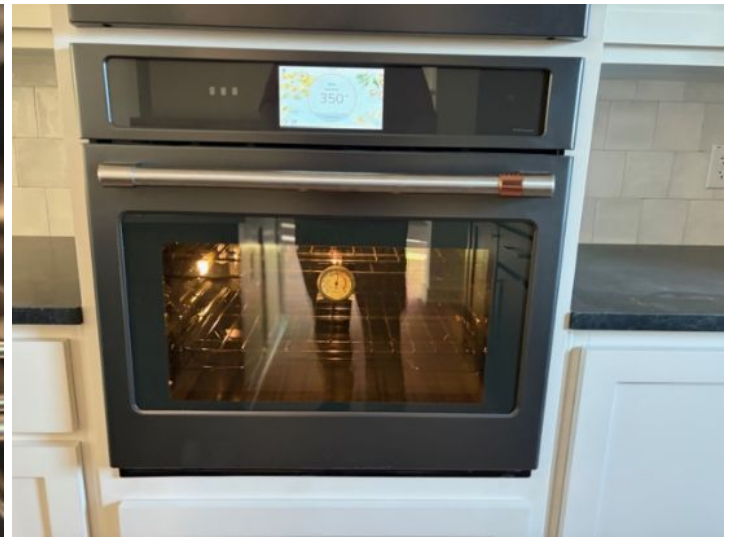
Stand-Alone Oven Temperature Test at 350°F

- Observation: An additional electric oven was observed and tested. The oven temperature was tested at 350°F and was found to be within an acceptable range ($\pm 25^\circ\text{F}$). No visible deficiencies were observed.

Recommendation: No action required at this time.

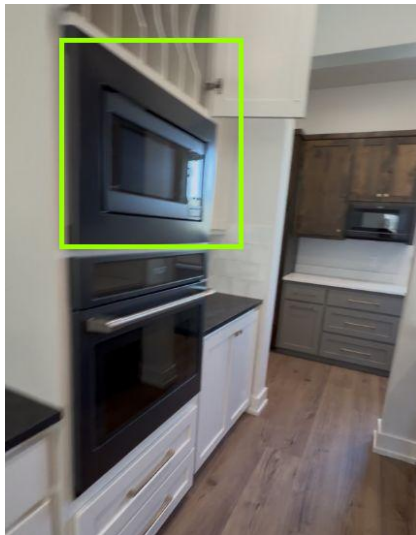
Kitchen Microwave

Observation: A microwave was observed in the kitchen. The unit was operated and found to be functional at the time of the inspection.

Recommendation: No action required at this time.

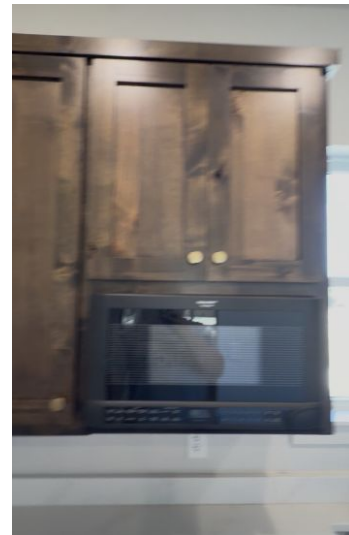
Walk-In Pantry Microwave

Observation: A second microwave was observed in the walk-in pantry. The unit was operated and found to be functional at the time of the inspection.

Recommendation: No action required at this time.

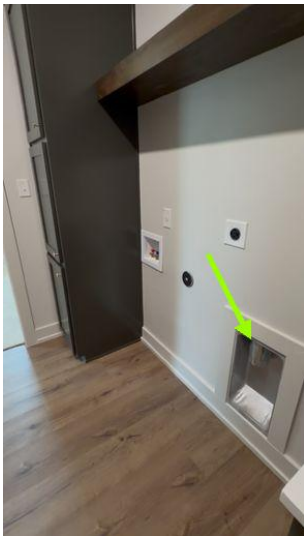
Laundry Room Dryer Vent

- Observation: The dryer exhaust system was observed. The laundry room exhaust components appeared to be in good condition, and the system vents to the exterior through a roof termination.

Implication: Properly installed dryer exhaust systems that vent to the exterior support safe operation and effective moisture and lint removal.

Recommendation: No action required at this time.
